EXISTING CONDITION STUDY
BREWER - MESIER HOMESTEAD
WAPPINGERS FALLS, NY

January 2018

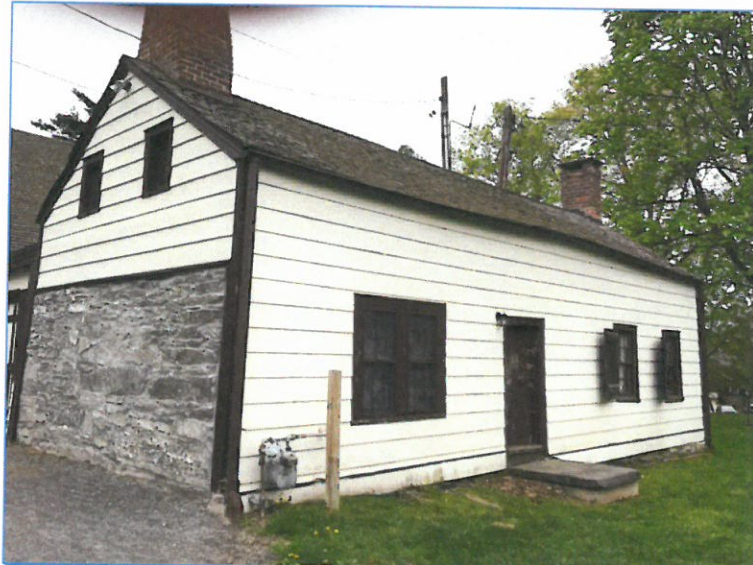
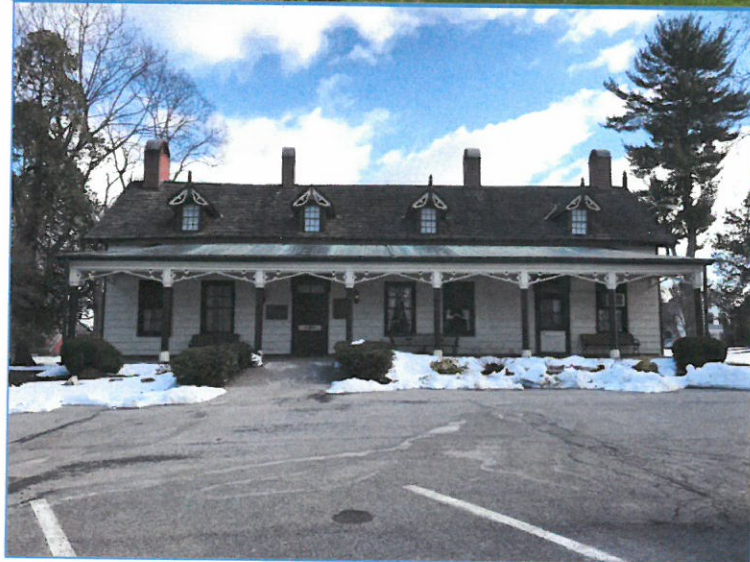
PRESERVATION / ARCHITECTURE

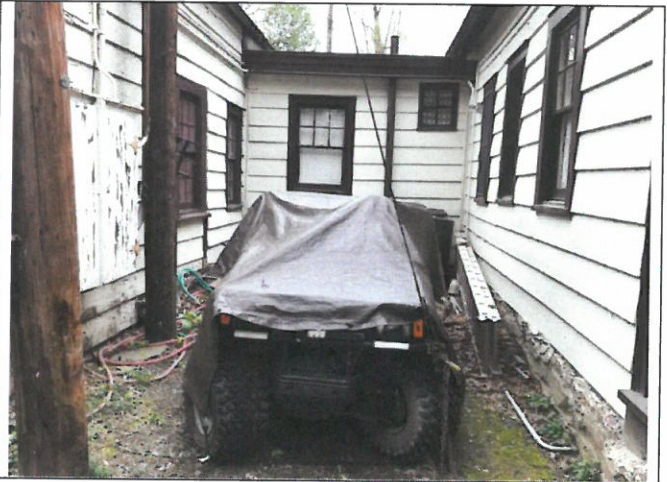
Photo 25. Area A on left, Area B connector ahead, Area C on right. Extensive drainage issues have caused foundation and sill damage.

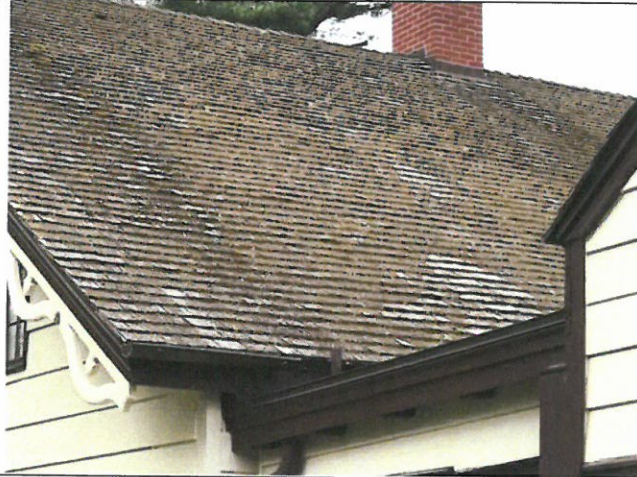
Photo 26. Area C and D roof, wood shingles (north elevation).

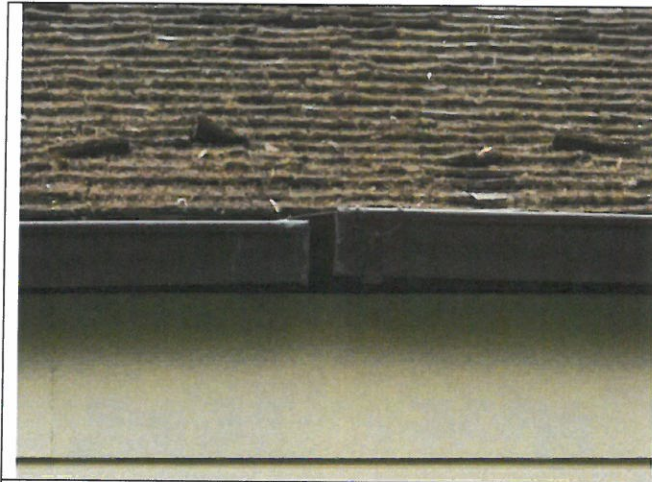
Photo 30. Area A, wood shingle deterioration, gutters.

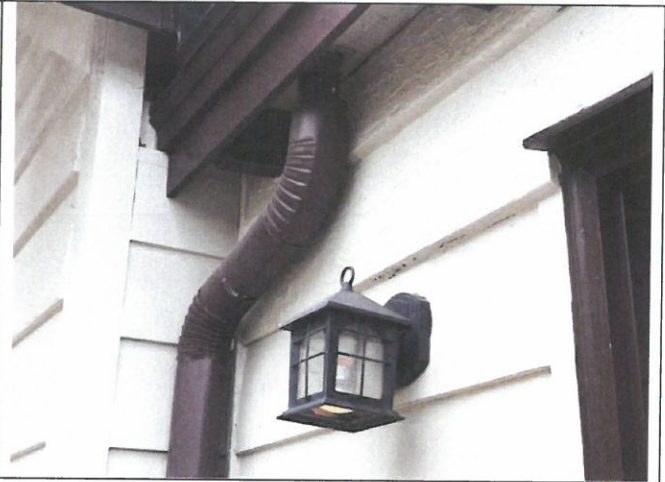
Photo 31. Area B, roof drainage.

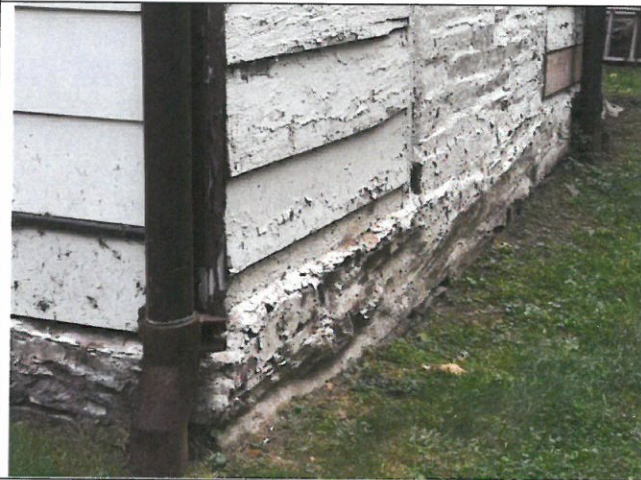
Photo 32. Area A, northwest corner stone foundation deterioration, typical.

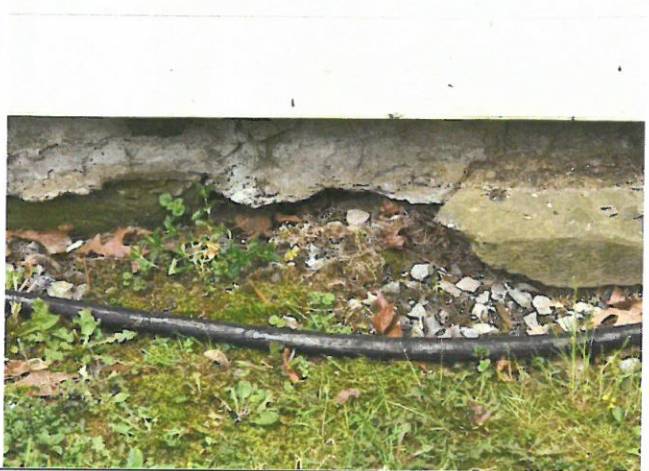
Photo 33. Area A, deteriorated foundation parging, typical.

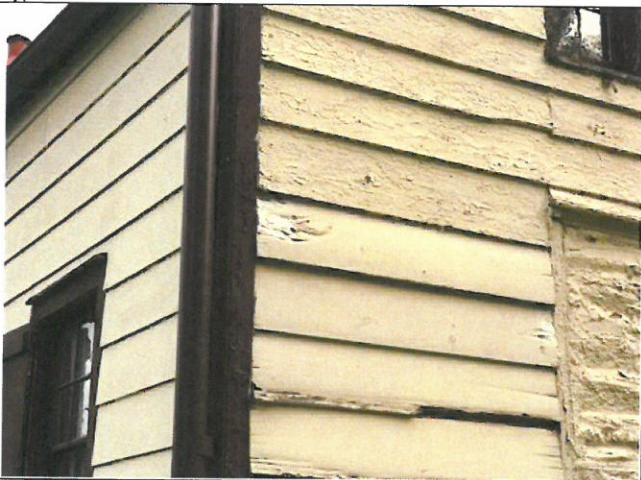
Photo 34. Area A, northwest corner, siding deterioration, typical.

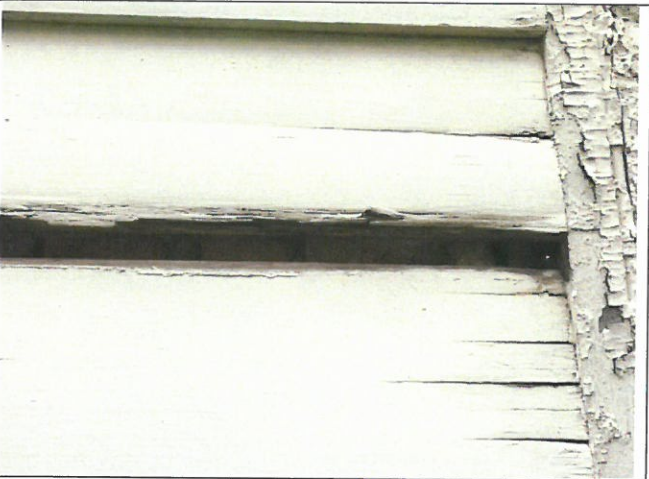
Photo 35. Siding and trim condition, typical.

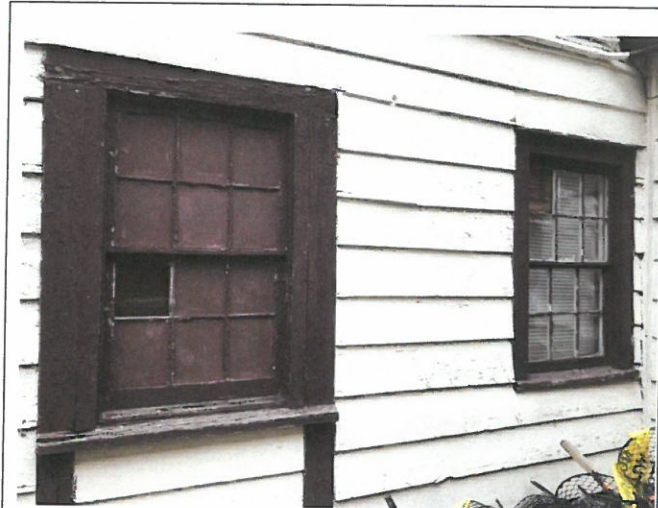
Photo 36. Area A, windows, south elevation.

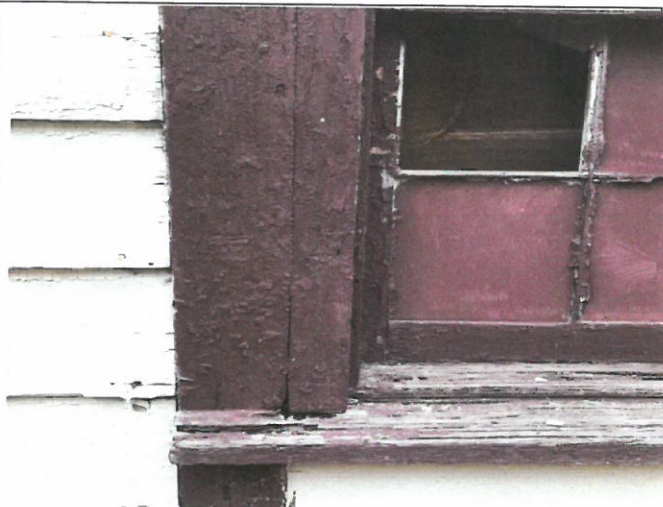
Photo 37. Area A, window, typical condition, windows and sills.

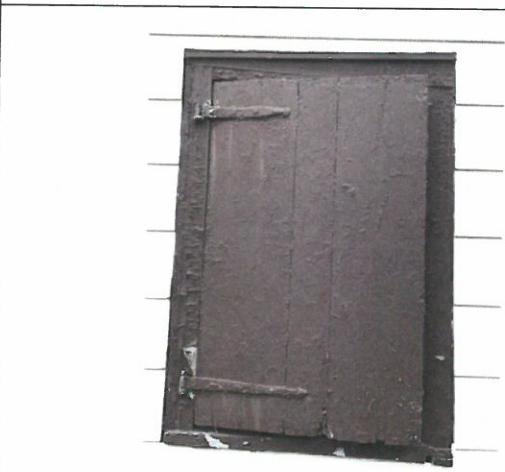
Photo 38. Area A, shutter and early hardware at window opening, south elevation.

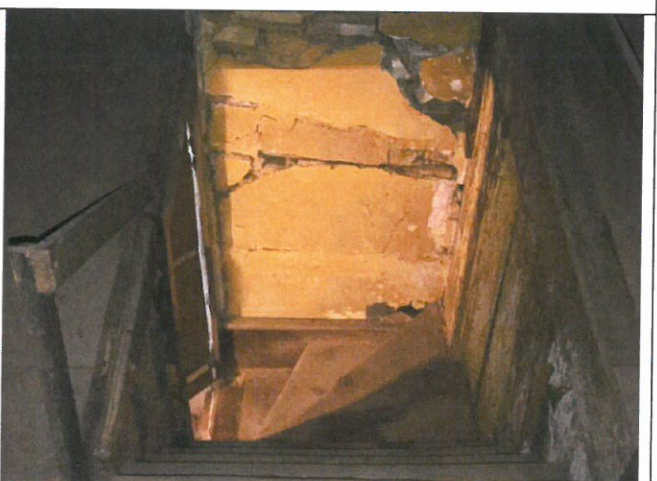
Photo 47. Area A, extreme deterioration (open to exterior) at south wall at base of stair, south elevation.

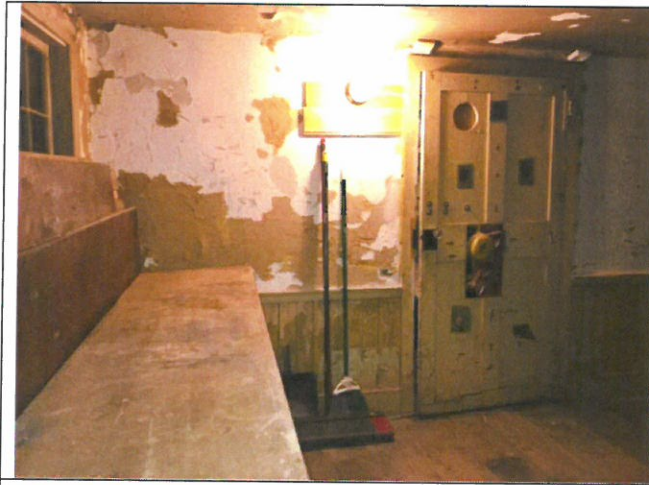
Photo 48. Area A, Room 101, looking east. Original/early wainscot, plaster, door.

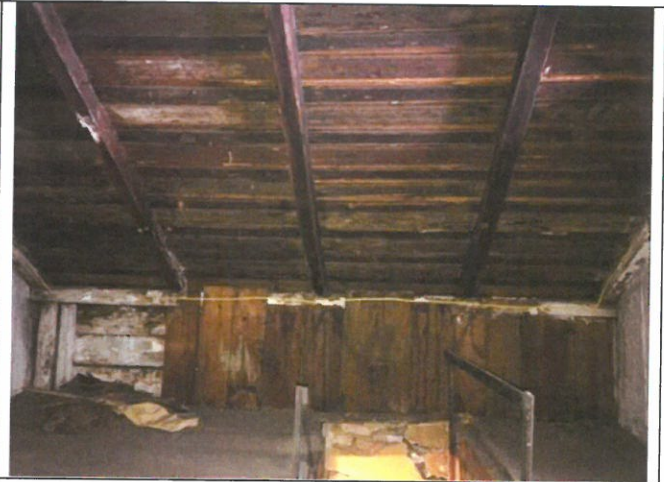
Photo 55. Area A, Room 202, condition of roof and wall framing, typical.

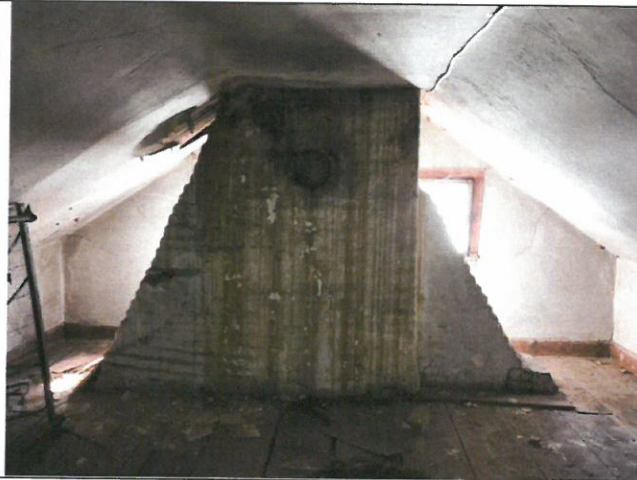
Photo 56. Area A, Room 203, modified chimney, looking east.

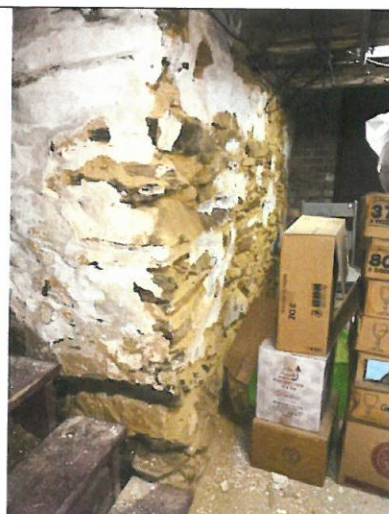
Photo 65. Area D, Room 002, loose and spalling stone at Stair 2.

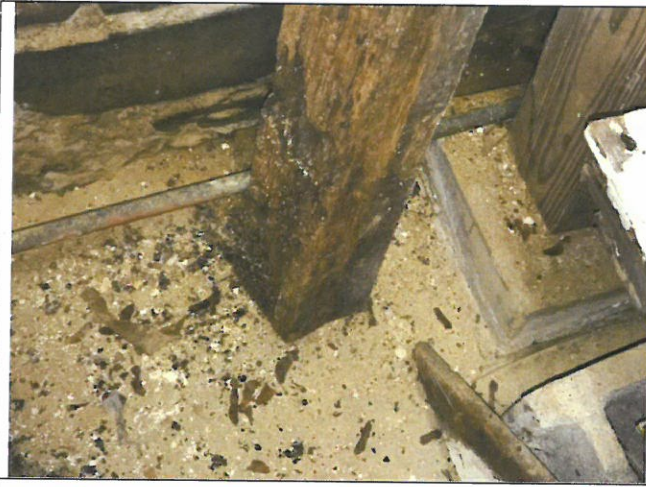
Photo 66. Area D, Room 001, southwest corner, evidence of infestation and deterioration, likely due to stored wood materials.

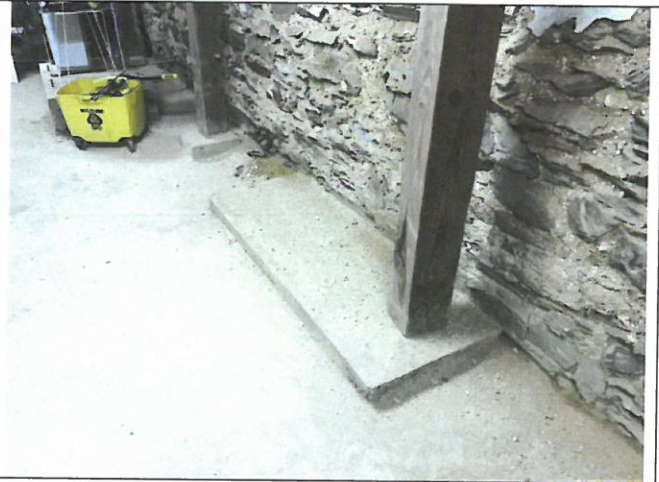
Photo 67. Area D, Room 001, north wall new posts and concrete slab.

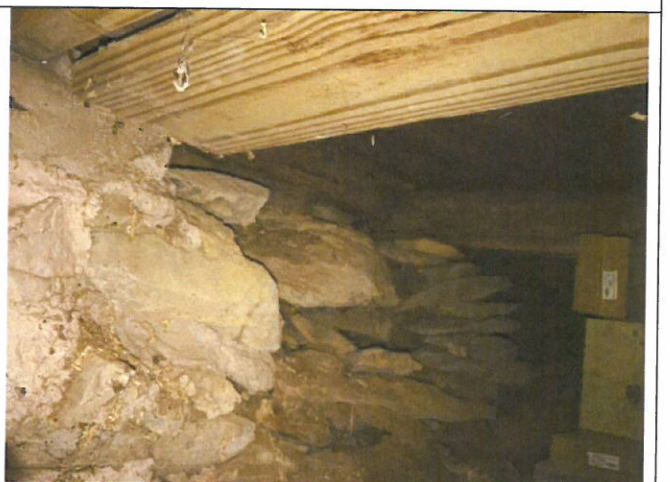
Photo 75. Area C, Room 105, view of replaced wood framing on stone wall in crawlspace, north wall.

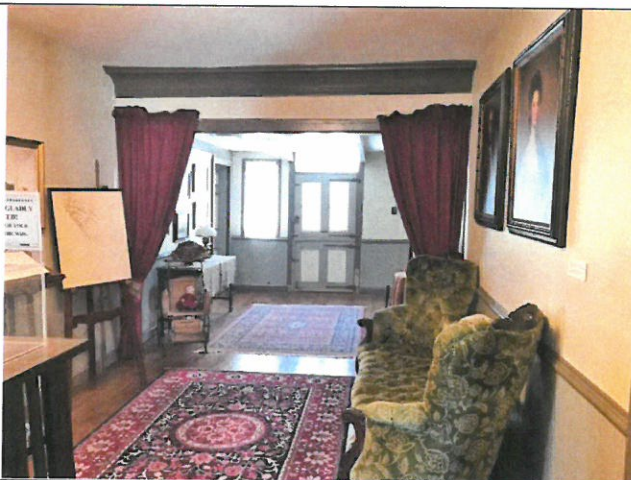
Photo 76. Area C, looking north to Room 106N.
