Mesier Homestead  
Wappingers Falls, New York

Exterior Paint Chronochronology

October 3, 2006

prepared for  
Village of Wappingers Falls  
Wappingers Falls, New York

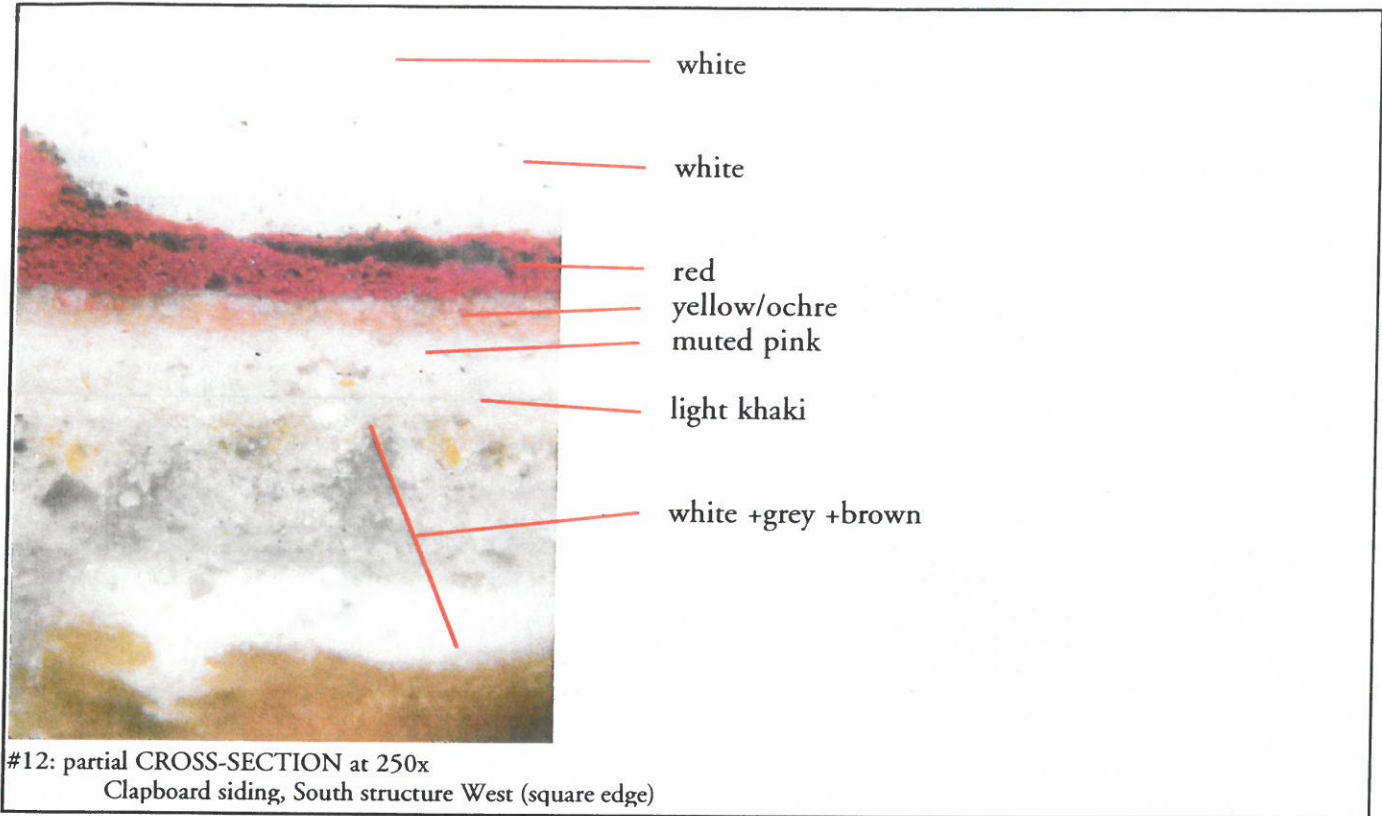
During Phase III, all siding was refinished uniformly, and some clapboard were replaced, either due to extraordinary wear or to related modifications. The replacement clapboard differ from the original clapboard in that they lack the decorative beaded edge detail. This Phase III finish was done in a Light Grey paint, with evidence of possible decorative treatment based on the discrete and variable appearance of a brown layer at the surface or alternately a dark olive layer. This might have been a finish used to resemble stone, which was commonly done to enhance the appearance of an otherwise modest wood building, and make it seem more substantial.

Window and door surrounds at the North and South structures were painted Dark Grey during this period. This is also the earliest finish found on the elements of the south-facing verandah, indicating that this was added at the time that clapboards were replaced and potentially other elements repaired or altered. It is notable that the porch ceiling panels and moldings, like the replacement clapboards, were primed with white prior to application of the grey paint, while other porch elements including columns and cornice were not primed in this manner. This may have been a function of the wood chosen for flat panels or siding versus decorative or milled elements.

This Phase III finish, based on its overall application to both structures, and its appearance as the earliest finish on many of the trim elements, is interpreted as the first Mesier campaign, shortly after 1776 when he acquired the house. It can be conjectured that when he first purchased the property, he made widespread changes to many of the trim and siding elements, and added the verandah, refinishing the whole in this grey, potentially “stone-look” scheme. While this would be the logical choice for recreation of a historical period finish, the decorative intent is not necessarily established by the samples viewed in cross-section, and the current weathered condition of the existing paint layers *in situ* precludes the option of small-scale exposures of the finish. Some decorative interpretation of the observed finish layers may be required for replication.

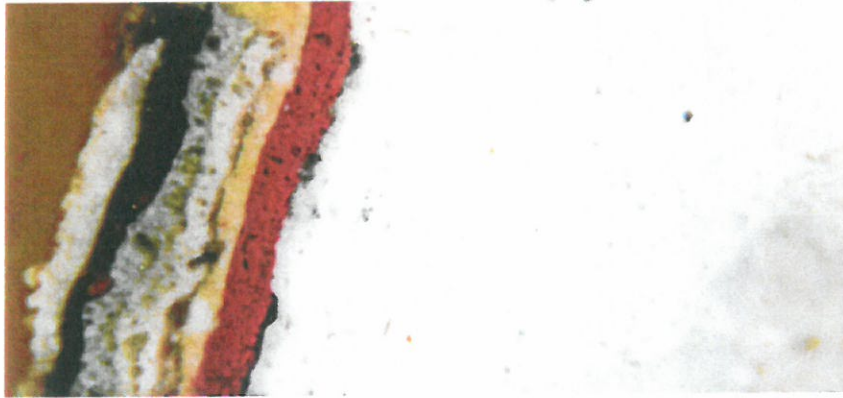
**SAMPLE #** 37  
**LOCATION** South elevation clapboard siding

SUBSTRATE	wood	NOTES
I	white	
IIa	dk grey	
IIb		
III	light grey	
IV	light khaki	
	muted pink	
	yellow	
	ochre	
	dark red	
	white	
	white	
	white	
	white	
	pale blue	
	pink-beige	
	cream	
	white

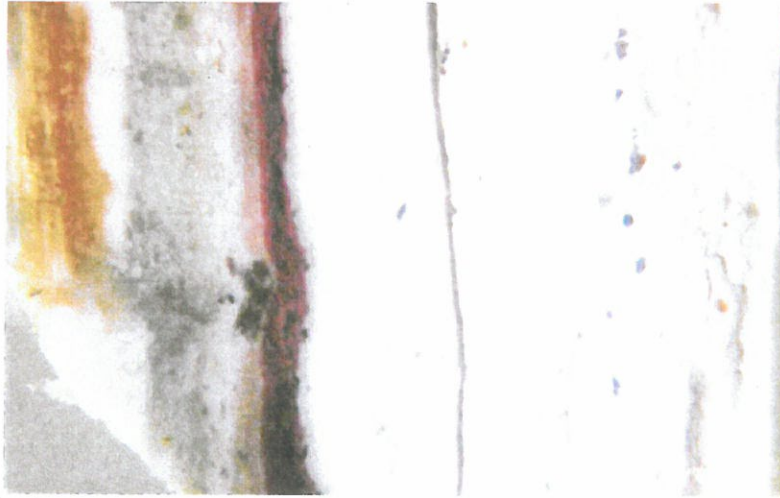
**SAMPLE #** 12

**LOCATION** West elevation, clapboard siding under gable

SUBSTRATE	wood	NOTES
I		
IIa		
IIb		
III	white P + light grey	
	brown	decorative?
IV	light khaki	
	muted pink	
	yellow	
	dark red	
	white	
	white	
	white	
	pale blue	
	pink-beige	
	cream	
	white

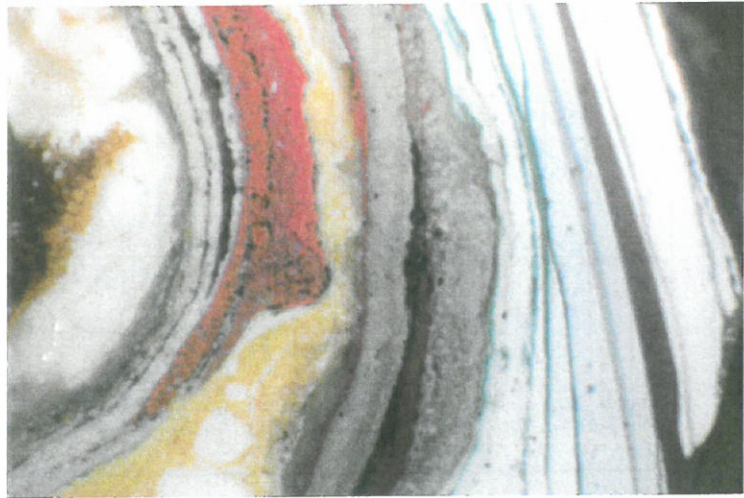
**SAMPLE #** 23  
**LOCATION** North elevation dormer window trim

SUBSTRATE	LAYER	NOTES
wood		
I		
IIa		
IIb		
III	dk grey	
IV	dark olive	
	dk red-brown	
	dark olive	
	white + green	
	white	
	dk green	
	br green	
	grey	
	dk grey	
	dk red-brown	
	dk red-brown

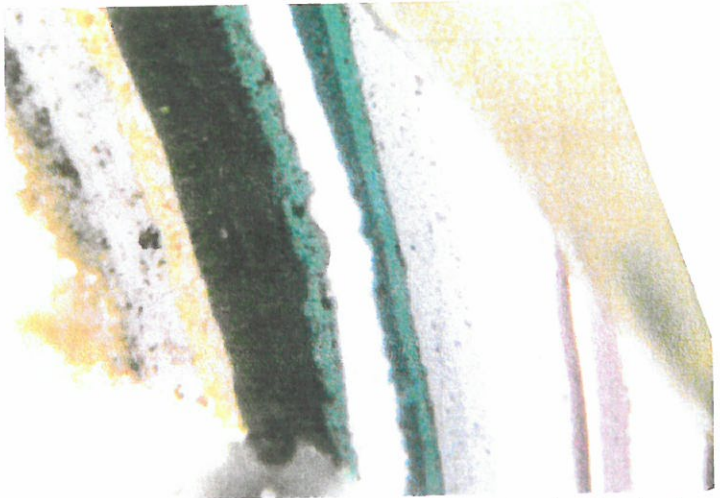
SAMPLE # 16  
 LOCATION Porch column shaft

SUBSTRATE	wood	
LAYER		NOTES
I		
IIa		
IIb		
III	grey	
	brown	decorative?
IV	khaki	
	putty	
	yellow	
	dk green	
	br green	
	white + dk green	
	br green	
	grey	
	light grey	
	pink beige	
	dk red-brown	
	white + red brown	
	white + dk red brown

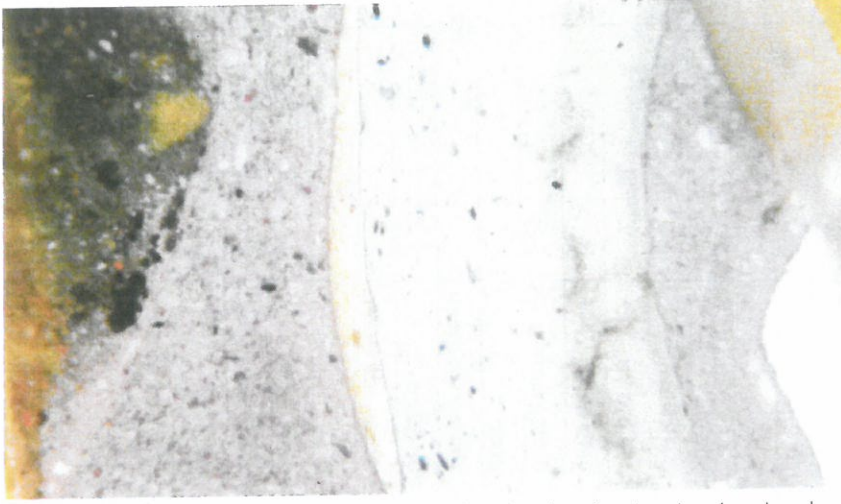
**SAMPLE #** 10

**LOCATION** West elevation, gable fretwork

- I \_\_\_\_\_
- IIa \_\_\_\_\_
- IIb \_\_\_\_\_
- III \_\_\_\_\_
- IV **dark olive** \_\_\_\_\_
- red brown** \_\_\_\_\_
- yellow** \_\_\_\_\_
- green** \_\_\_\_\_
- dark green** \_\_\_\_\_
- white** \_\_\_\_\_
- white** \_\_\_\_\_
- pale blue** \_\_\_\_\_
- white** \_\_\_\_\_
- pink beige** \_\_\_\_\_
- white** \_\_\_\_\_
- cream** \_\_\_\_\_
- \_\_\_\_\_
- \_\_\_\_\_
- \_\_\_\_\_

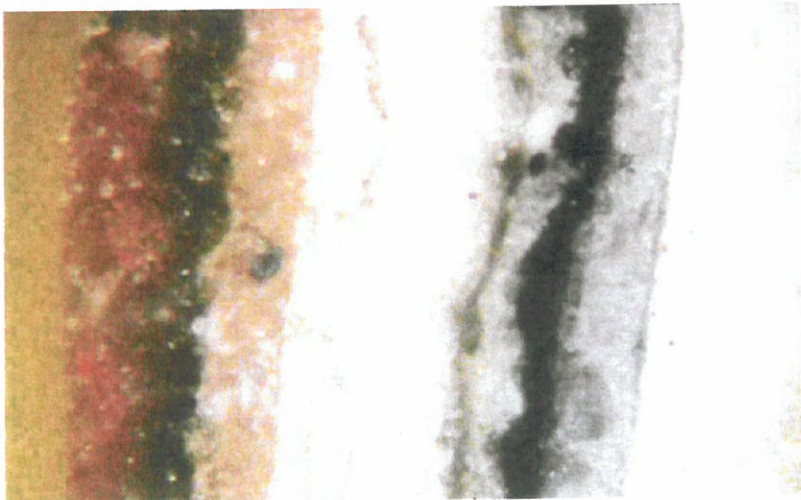
**SAMPLE #** 38

**LOCATION** South elevation siding behind connector

dark grey

white

grey

light grey
